# Manhole Inspection Summary

## Manhole # S17WW1007MH

**Location** Address: **CLYBURN AVE**

Cross Street: **NORTHERN PKWY**

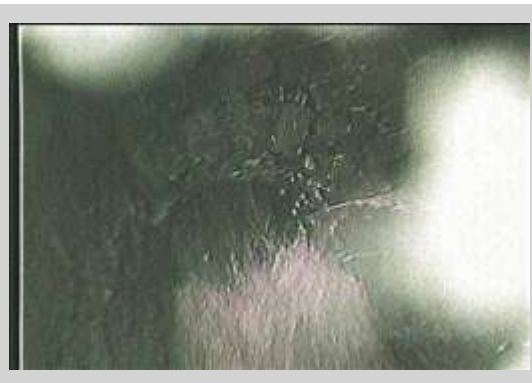
### Drop In @ 6 O'Clock

Drop: **Outside** Rod and Bar

Angled: **Yes** Reading: **10.89** (ft.)

Drop Condition: **Open**
